QUARTERLY SITE INSPECTION REPORT

BAILEY SUPERFUND SITE ORANGE COUNTY, TEXAS

August 28, 1998

PREPARED BY: CECOS INTERNATIONAL, INC.

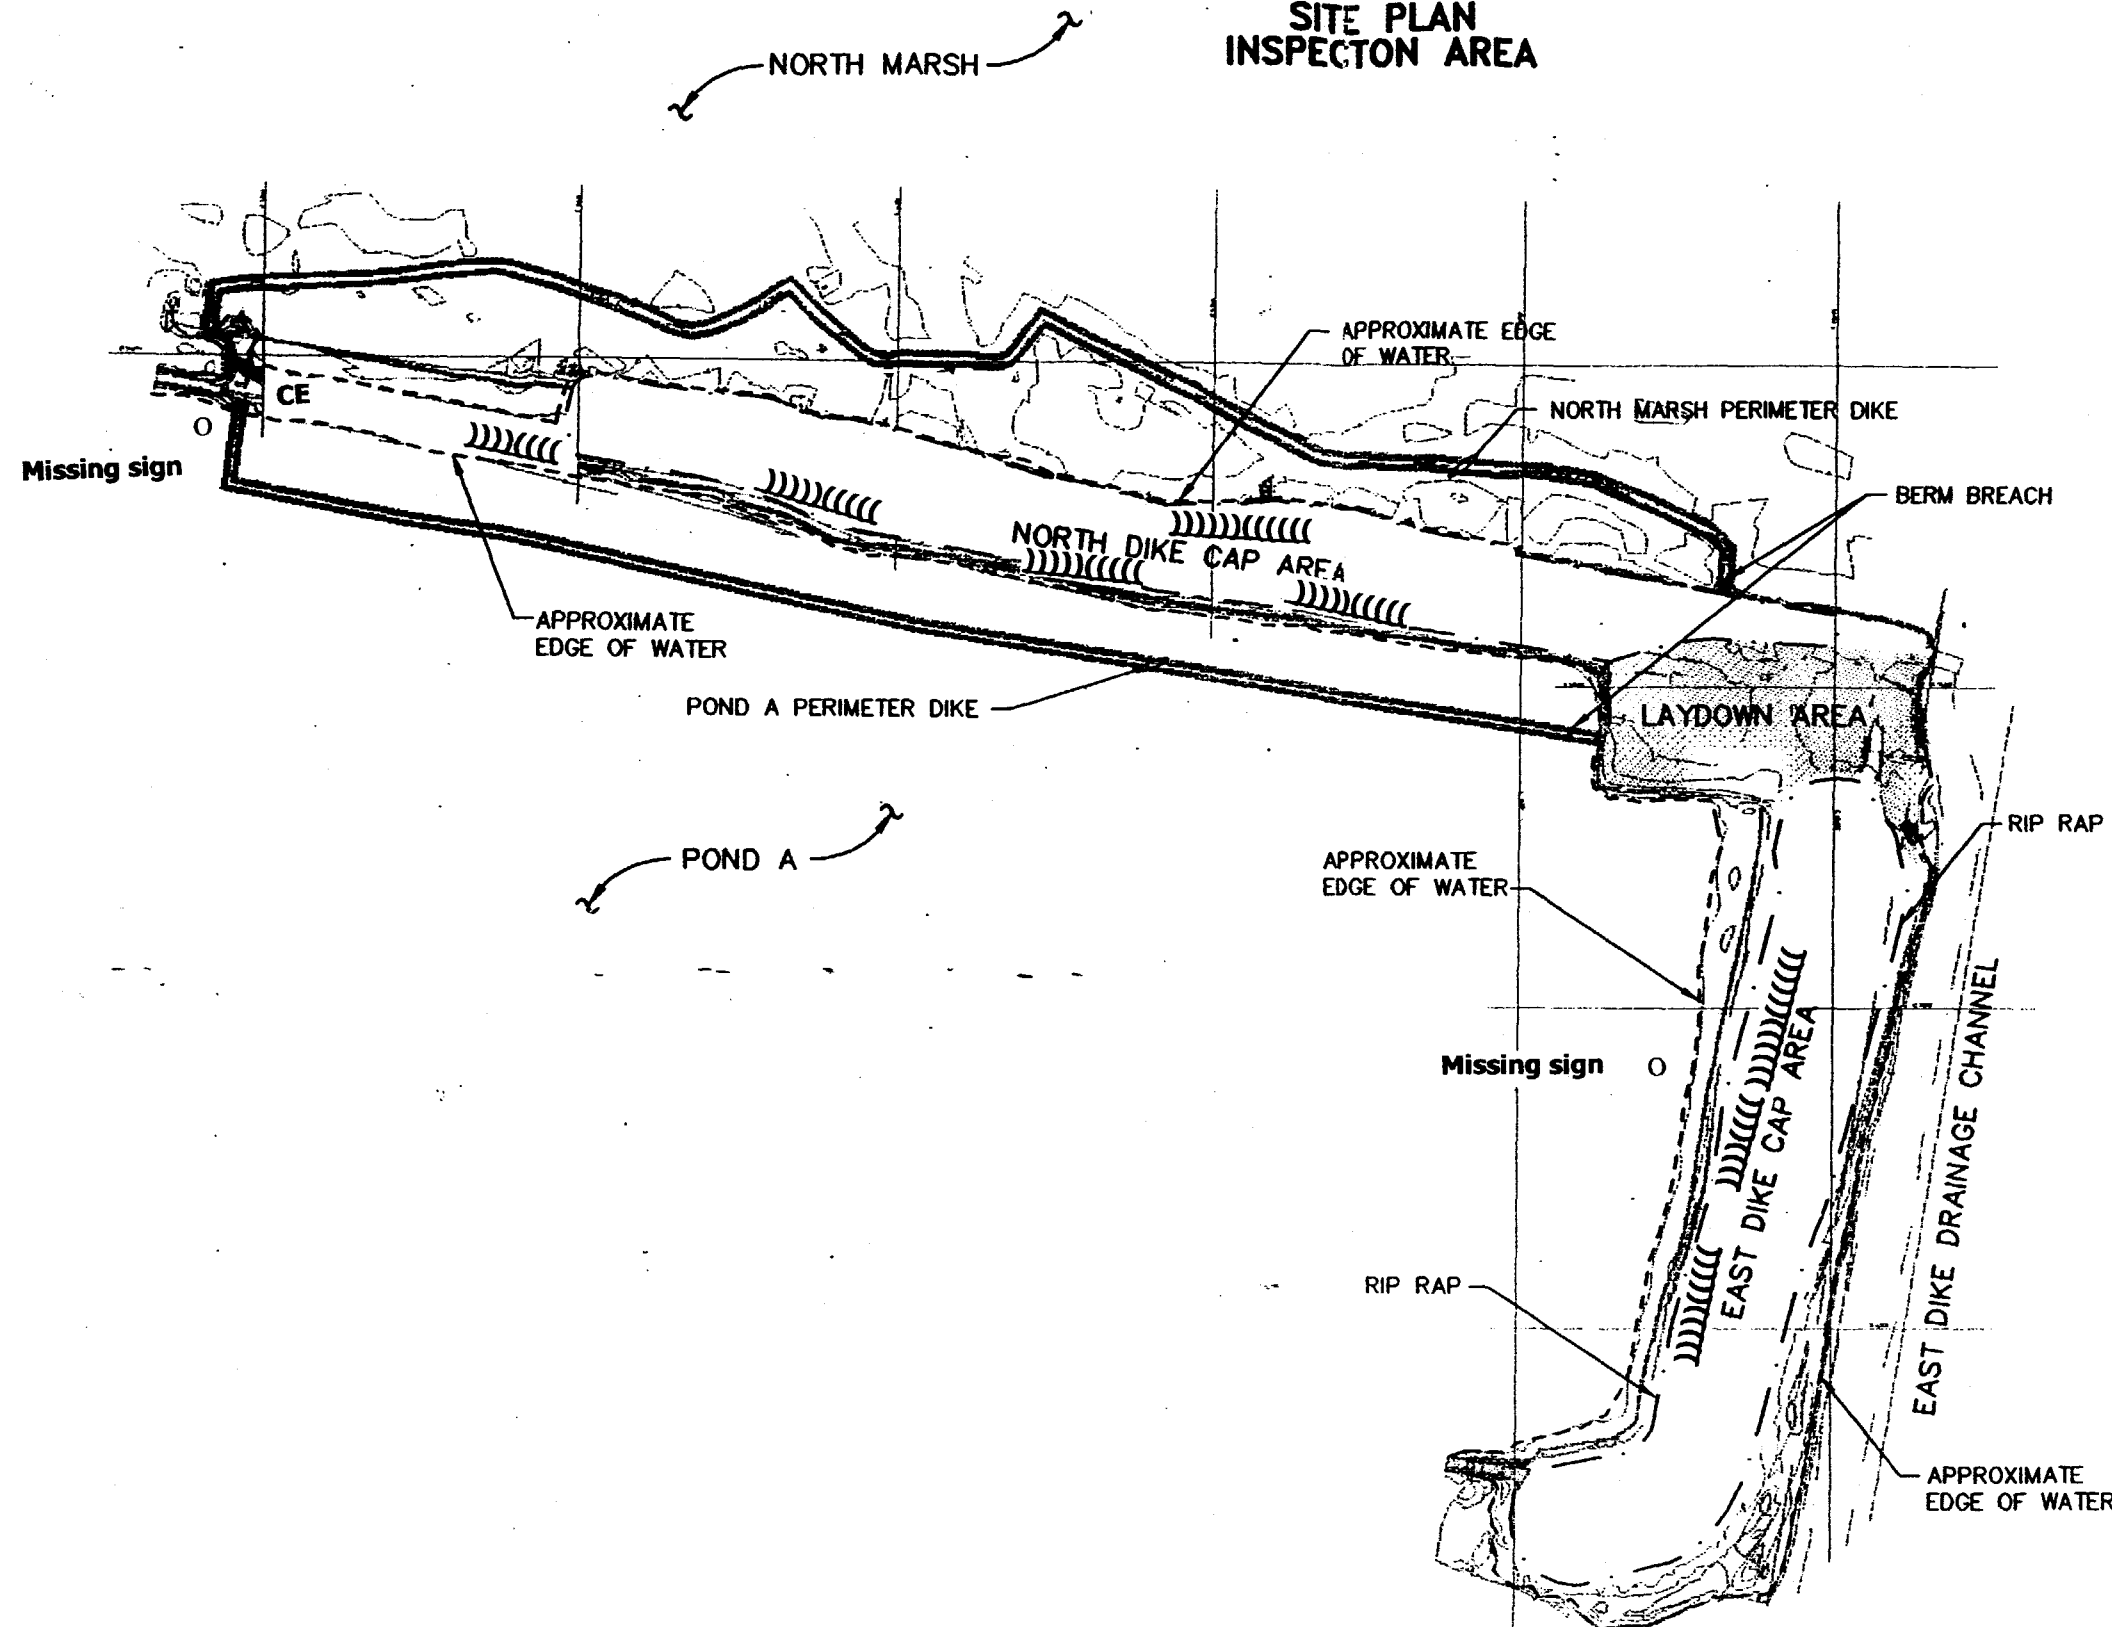
| PROJECT NO. GE3913-620 | FIGURE NO. 2.1 |

- EXISTING CONTOUR (FEET)
- ANCHOR TRENCH
- APPROXIMATE LIMIT OF GRAVEL SURFACING
- Channel Erosion = CE
- Missing sign = O
- Area of possible Differential Settlement

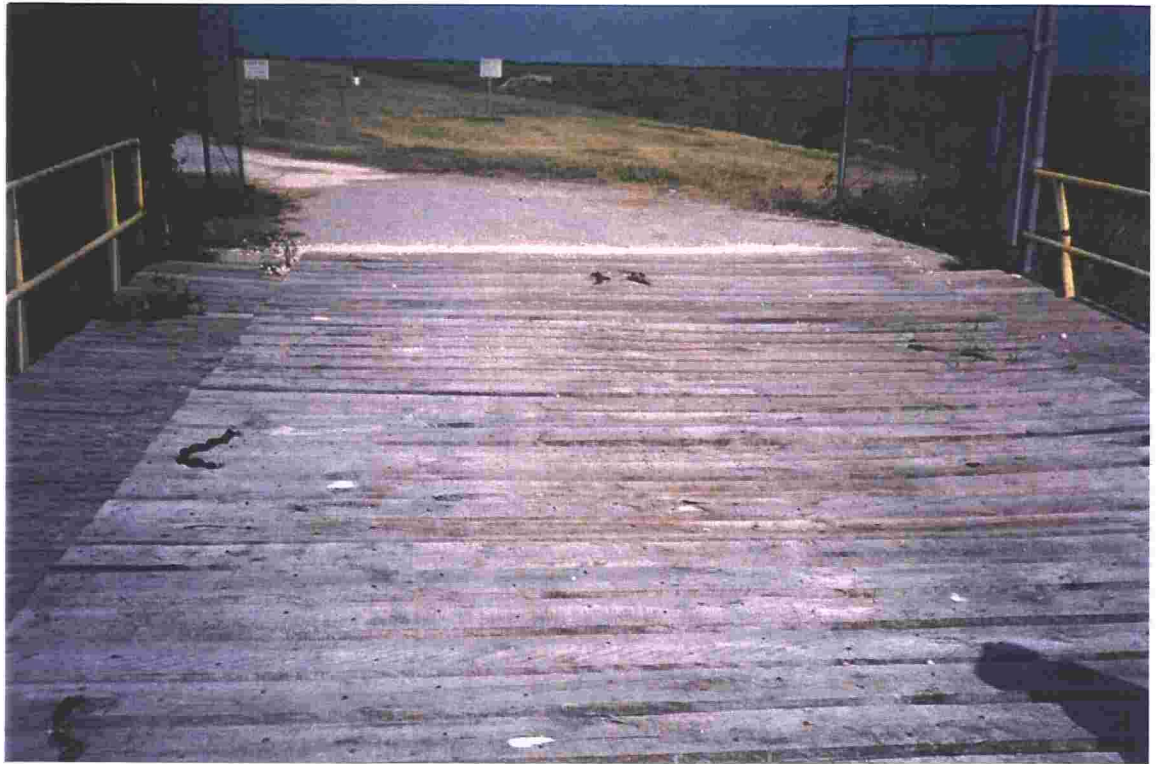
Access bridge in good condition- looking towards site

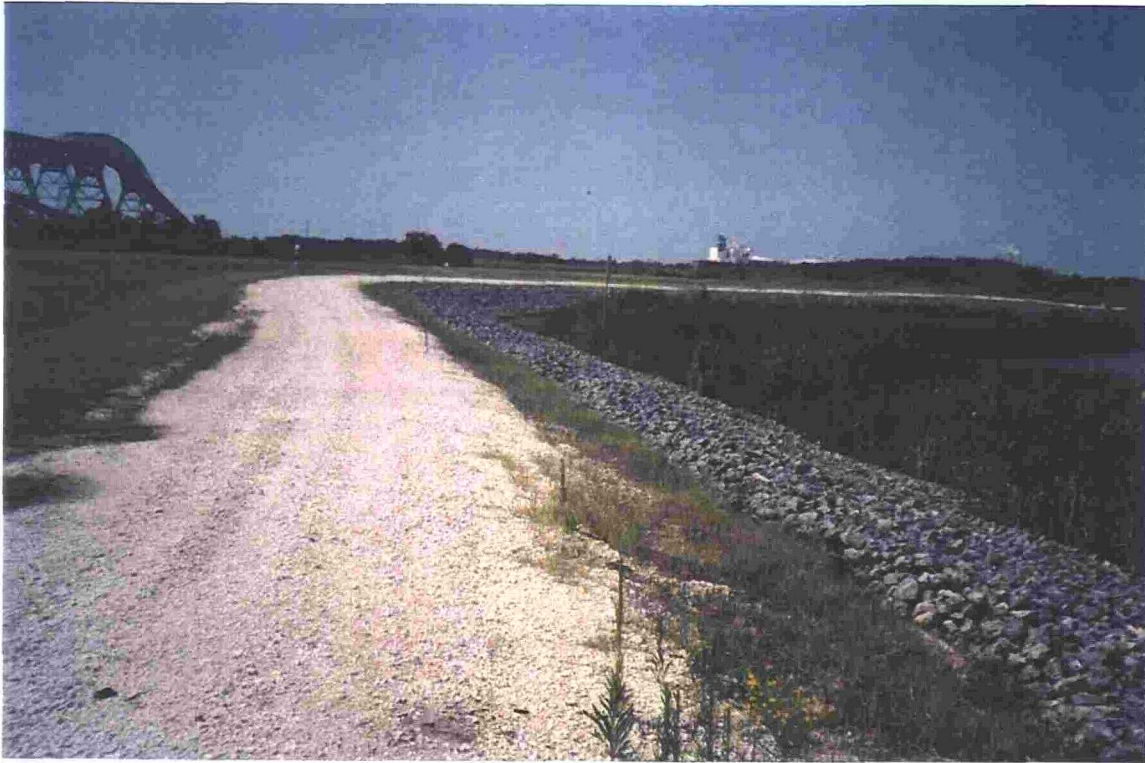
Site shell road in good condition- looking south

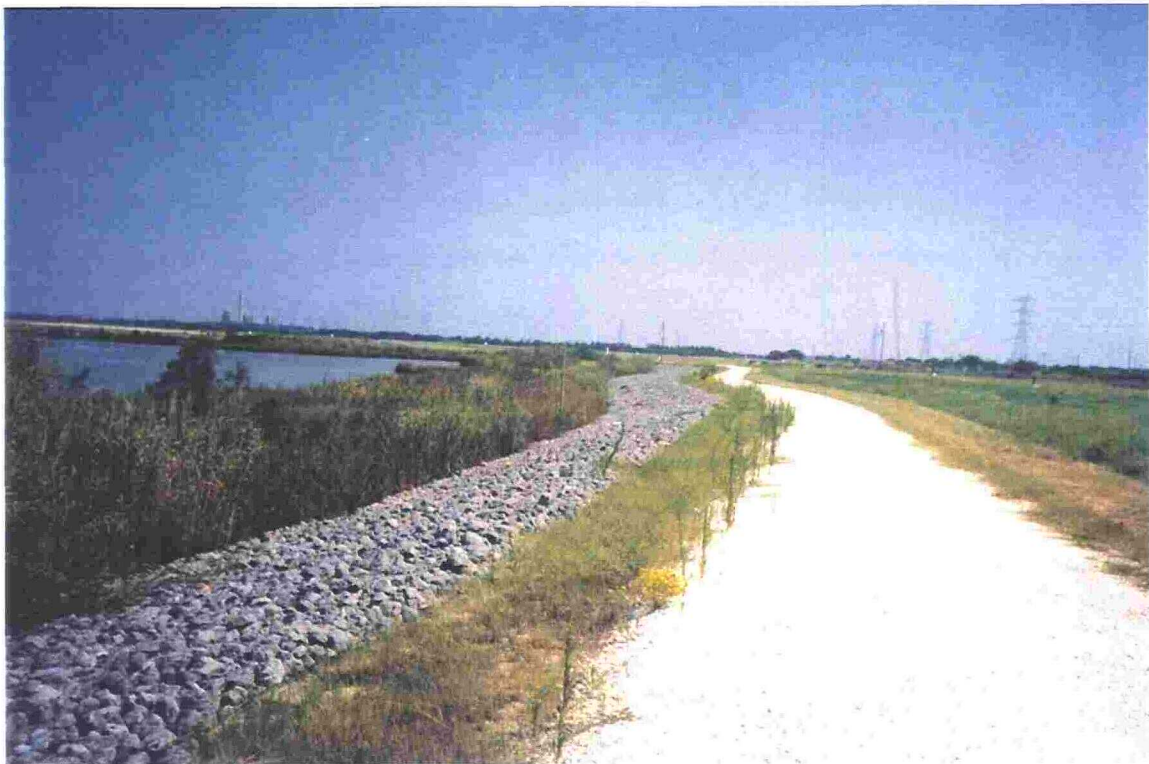
Site shell road in good condition- looking north

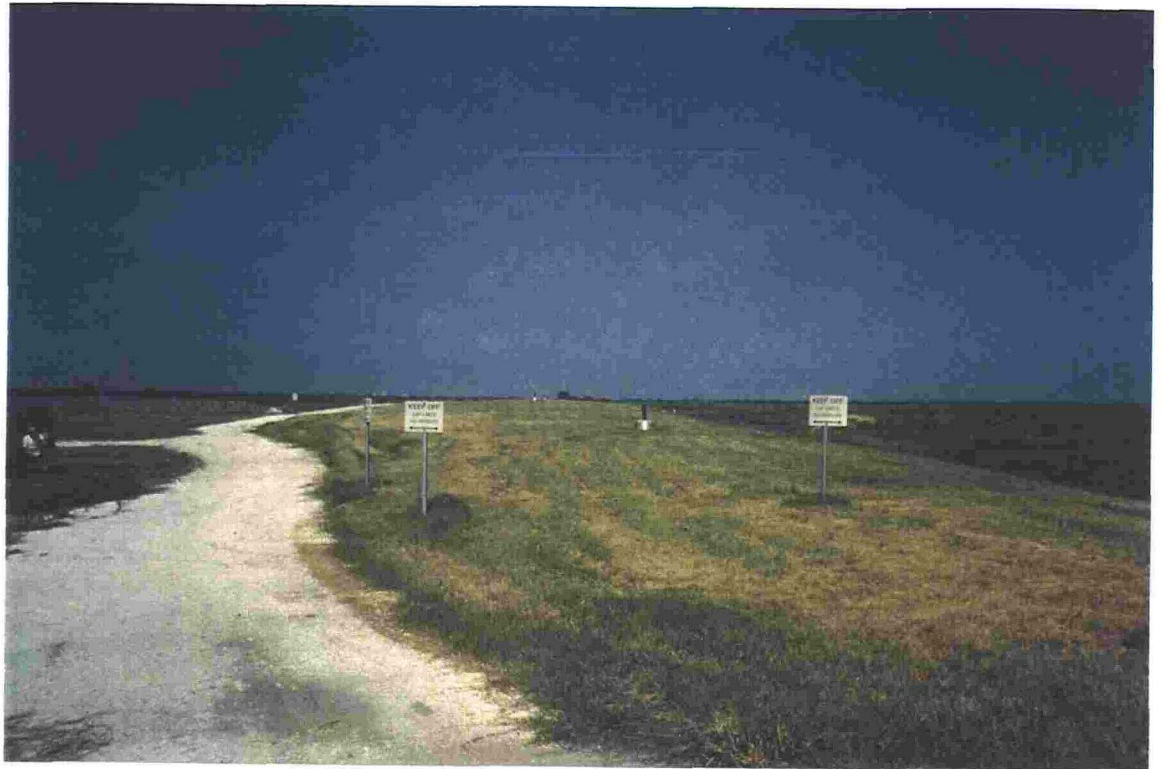
North Dike recently mowed with all cap limits signs in place

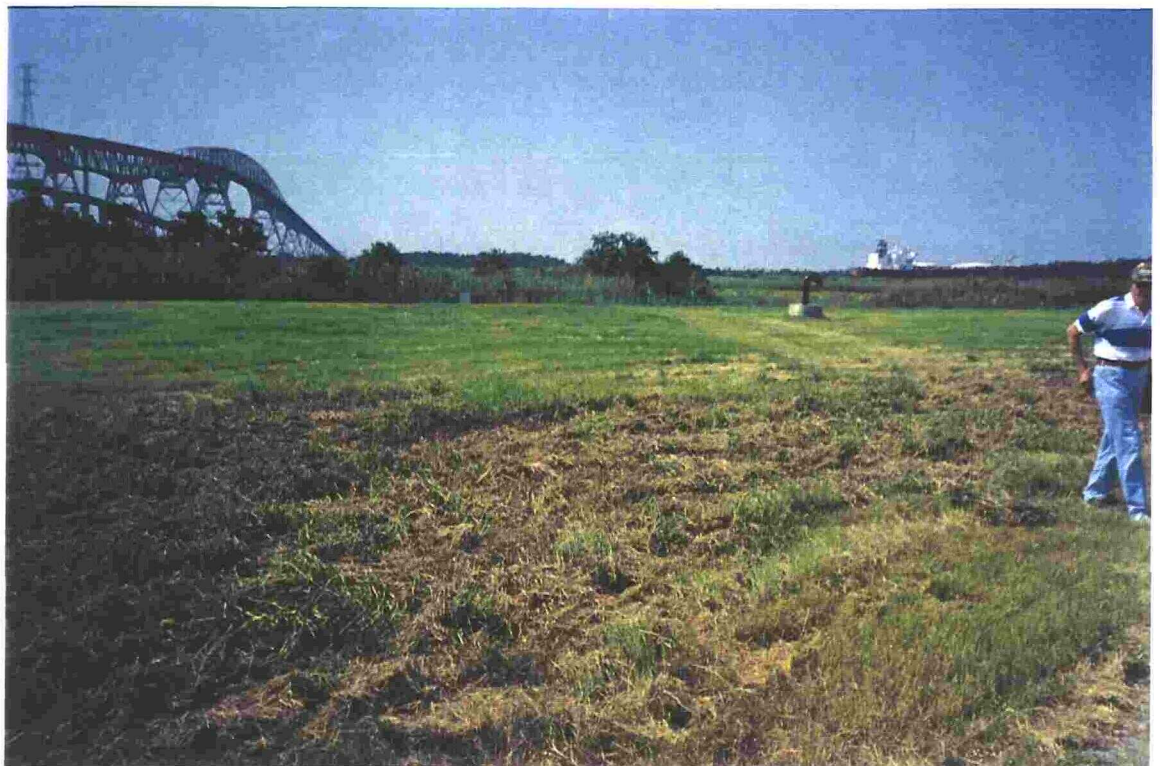
The North and East Dike areas were carefully observed for signs of differential settlement. There were signs of differential settlement in small, localized areas. Five areas of settlement averaging 400 square feet of surface area were observed on the North Dike. Three areas were located on the East Dike; the largest measured 3,000 square feet of surface area. All areas of settlement were estimated at two to four inches. Although no ponded water was present during the inspection, the areas of settlement were saturated.

The areas of differential settlement on the North and East Dike protective soil layer within the limits of the lightweight geosynthetic cap system.

Area of differential settlement on south side of East Dike

Place six inches of topsoil in areas where differential settlement was noted to occur. Reseed areas with bermuda grass or a bermuda/rye mixture, depending on growing season recommendations. Add fertilizer at the rates shown on the attached soil test report from the Texas Agricultural Extension Service.

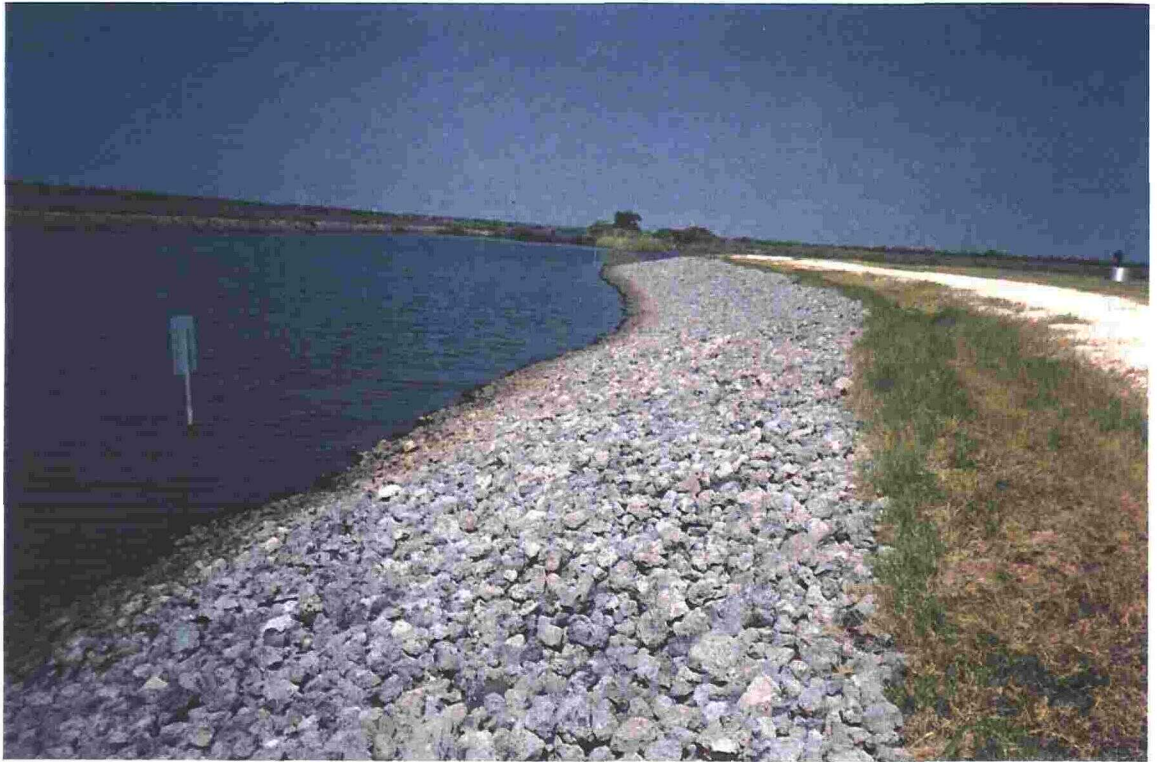
The rip-rap area located outside of the geosynthetic composite cap system limits on the western end of the North Dike, adjacent to the Pond A bank, which has previously been identified as a possible area of differential settlement has shown some change since the last inspection on May 29, 1998.

The area of differential settlement in the rip-rap material located on the south-central side of the North dike.

Rip-Rap area where differential settlement is occurring-
South side of North Dike

Redistribute rip-rap material with a rubber tire backhoe to establish a consistent slope.

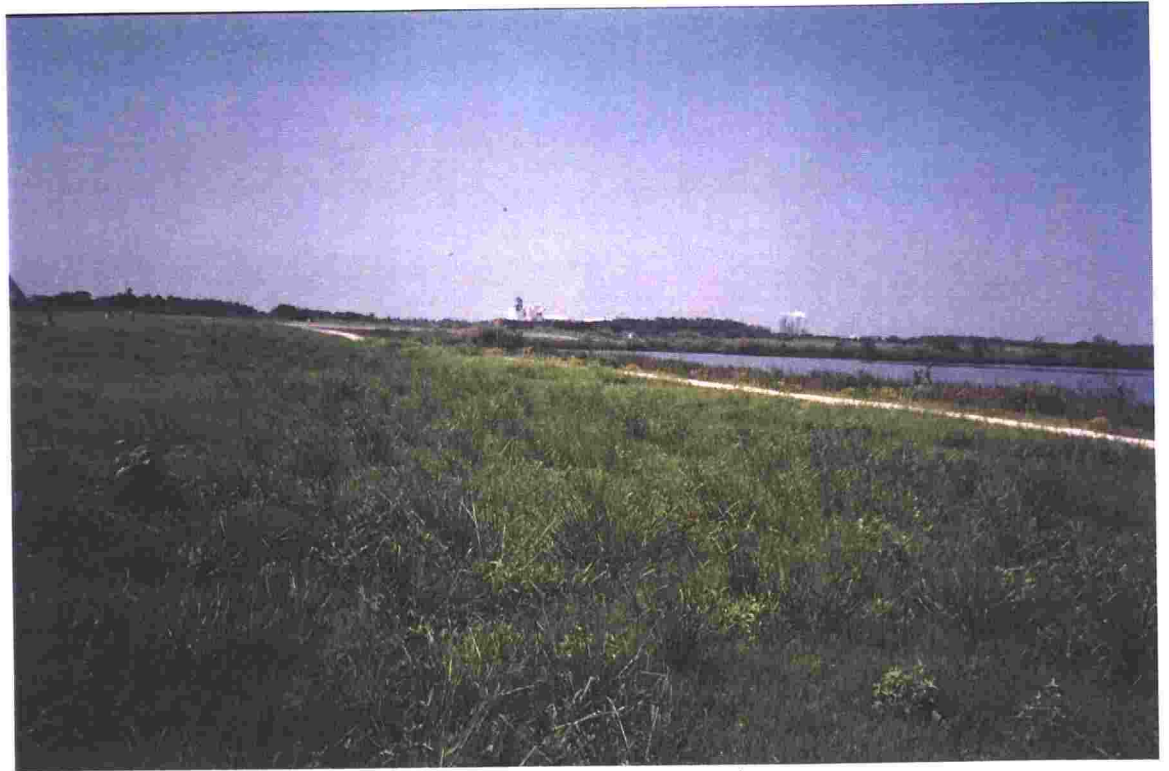
Areas of differential settlement- East Dike

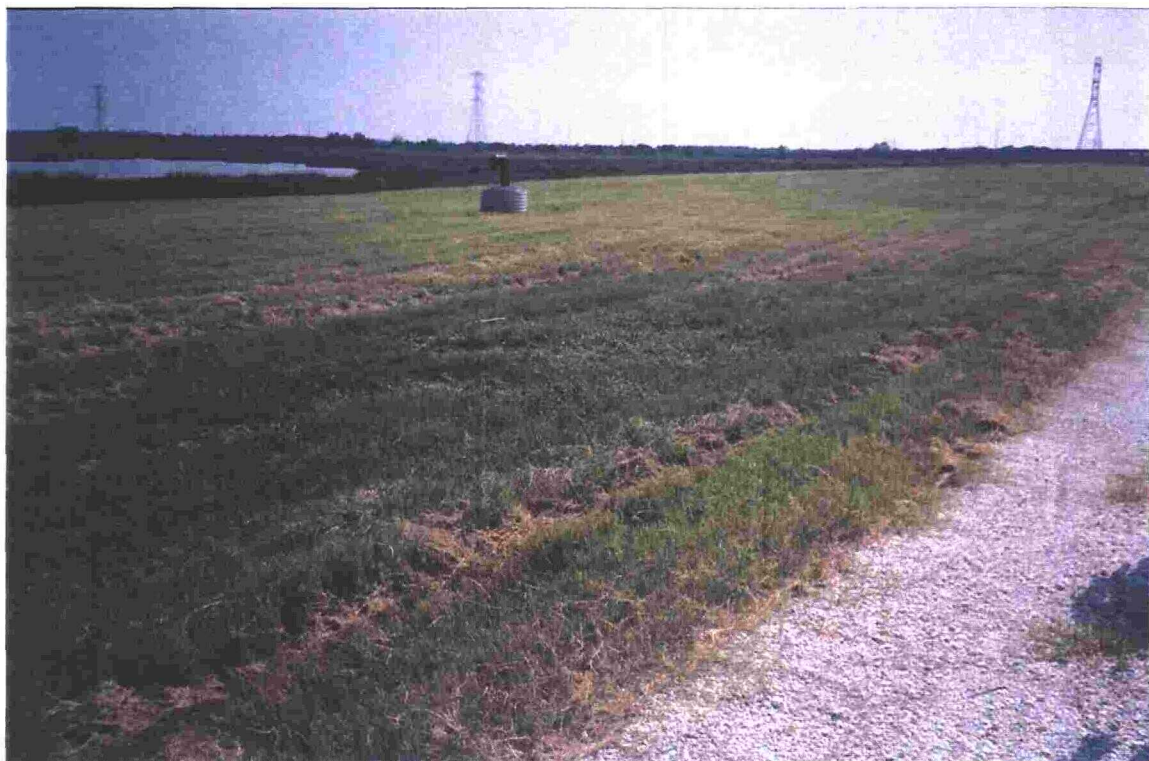
Areas of differential settlement- North Dike

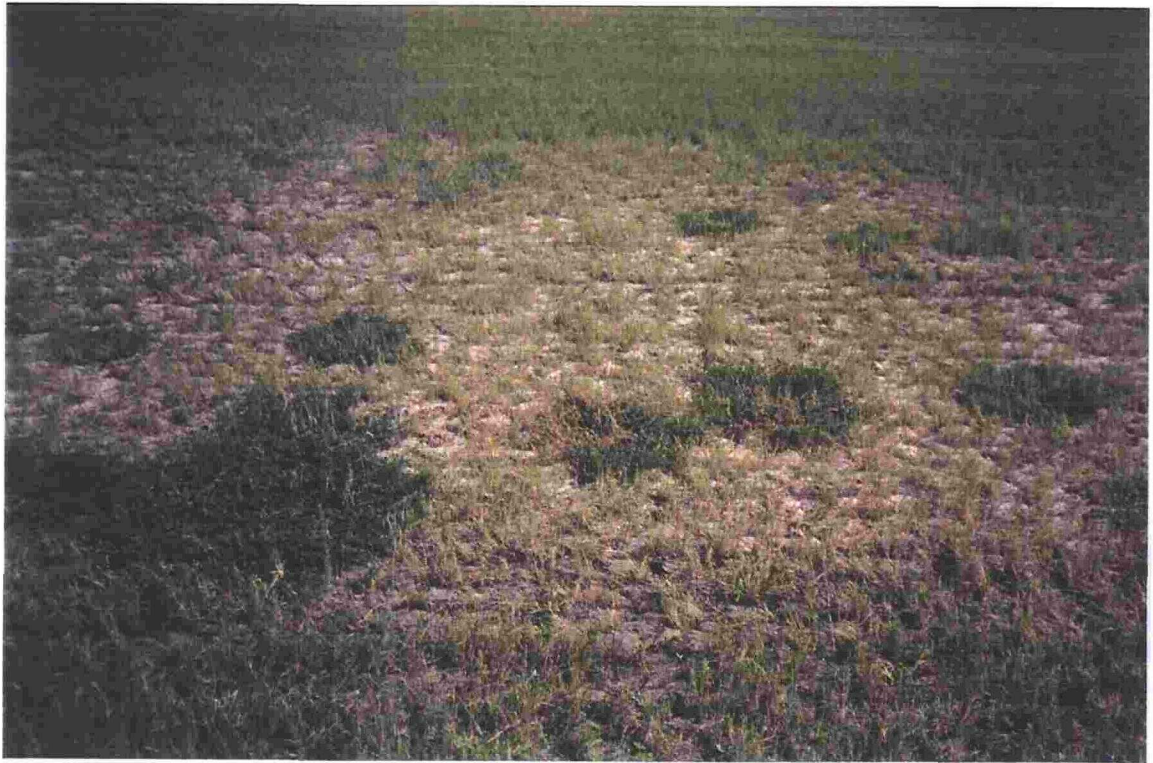
Areas where vegetation needs to be stimulated.

Sparse vegetation on south end of East Dike

Add fertilizer and seed to these areas when placing topsoil to correct differential settlement. (See Recommendation No. 1 above)

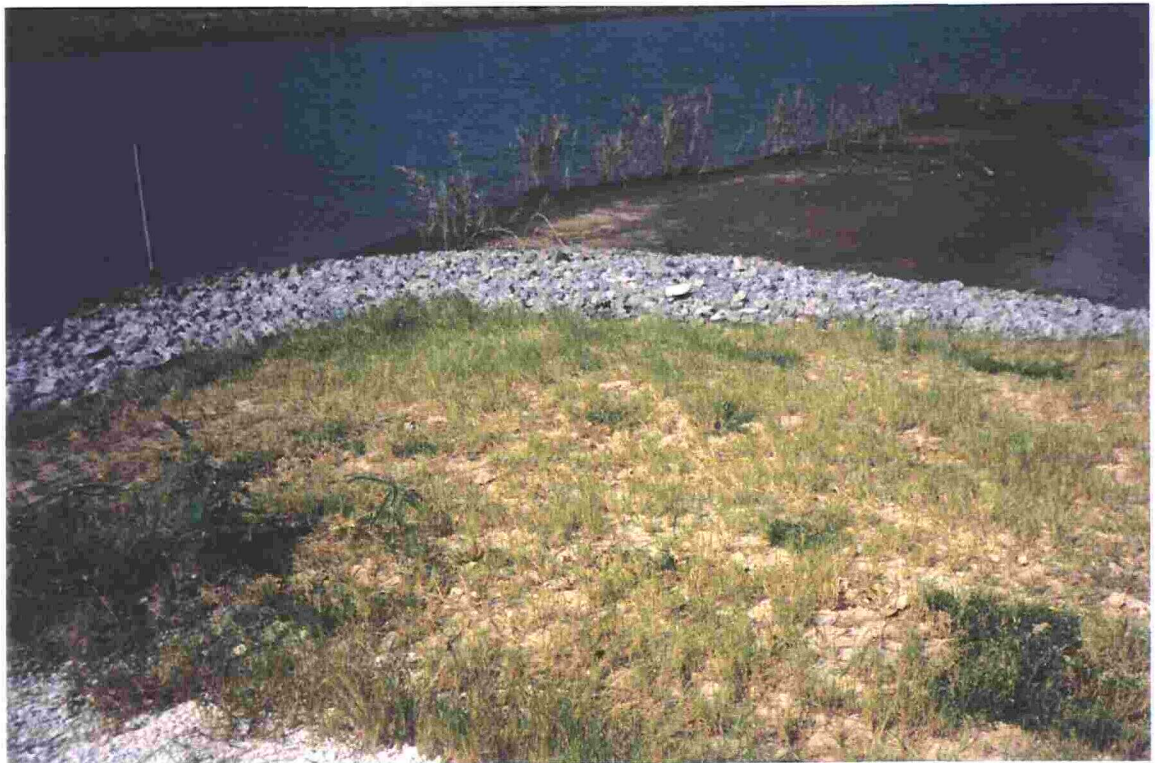
Road shell at west end of North Dike channeled due to rainfall runoff.

Area of erosion channeling- West end of North Dike

Eliminate erosion potential by spreading shell out with tractor boxblade and placement of fill in areas of differential settlement.

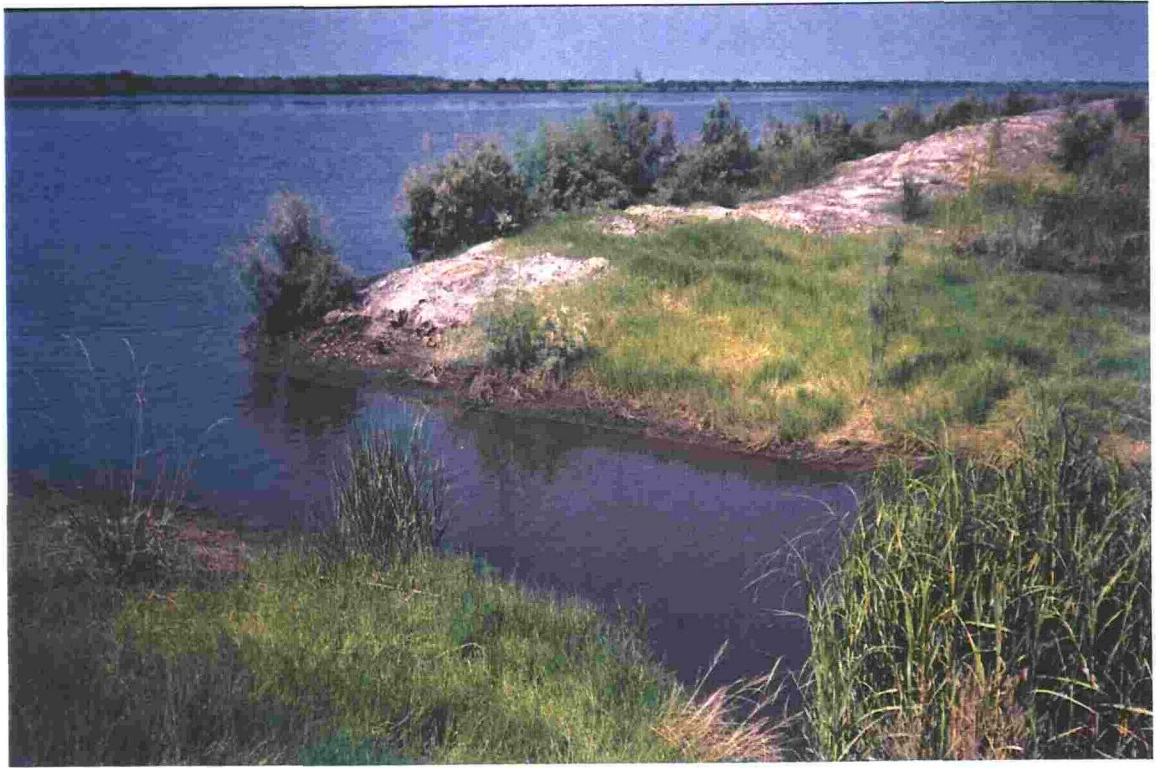
The North Dike Breaches in good condition and allowing free tidal flow

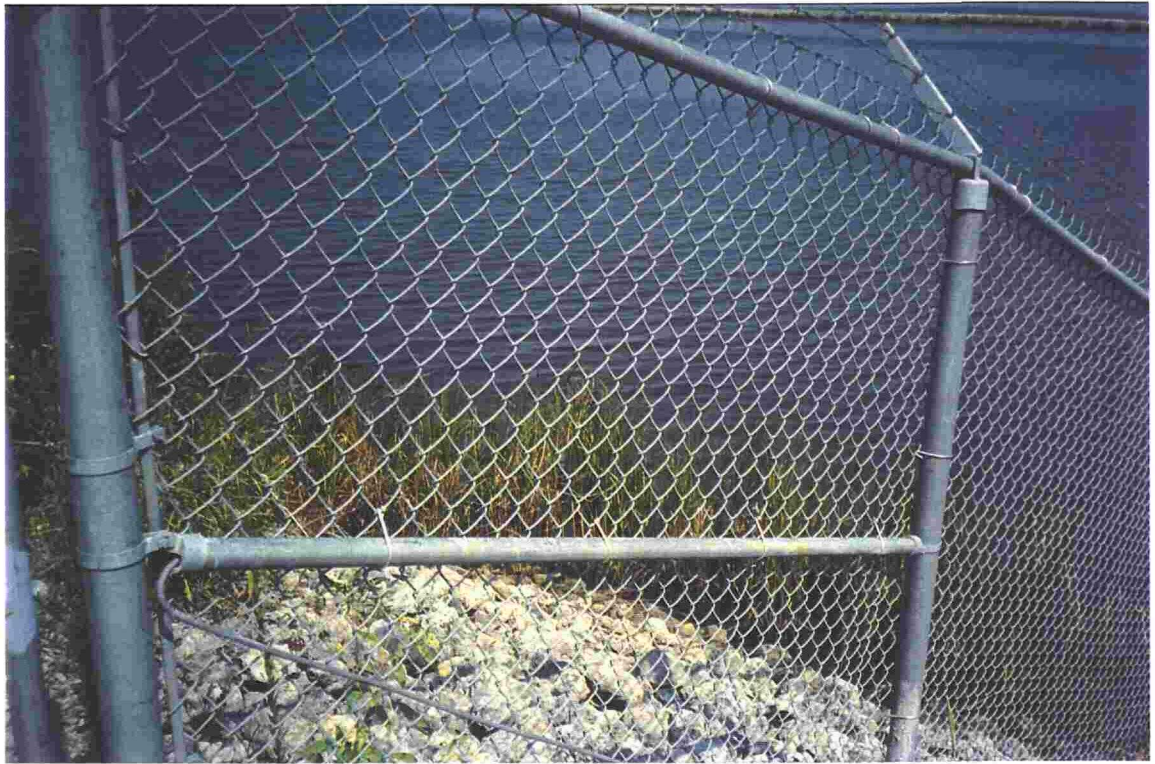
The East Dike Breaches in good condition and allowing free tidal flow

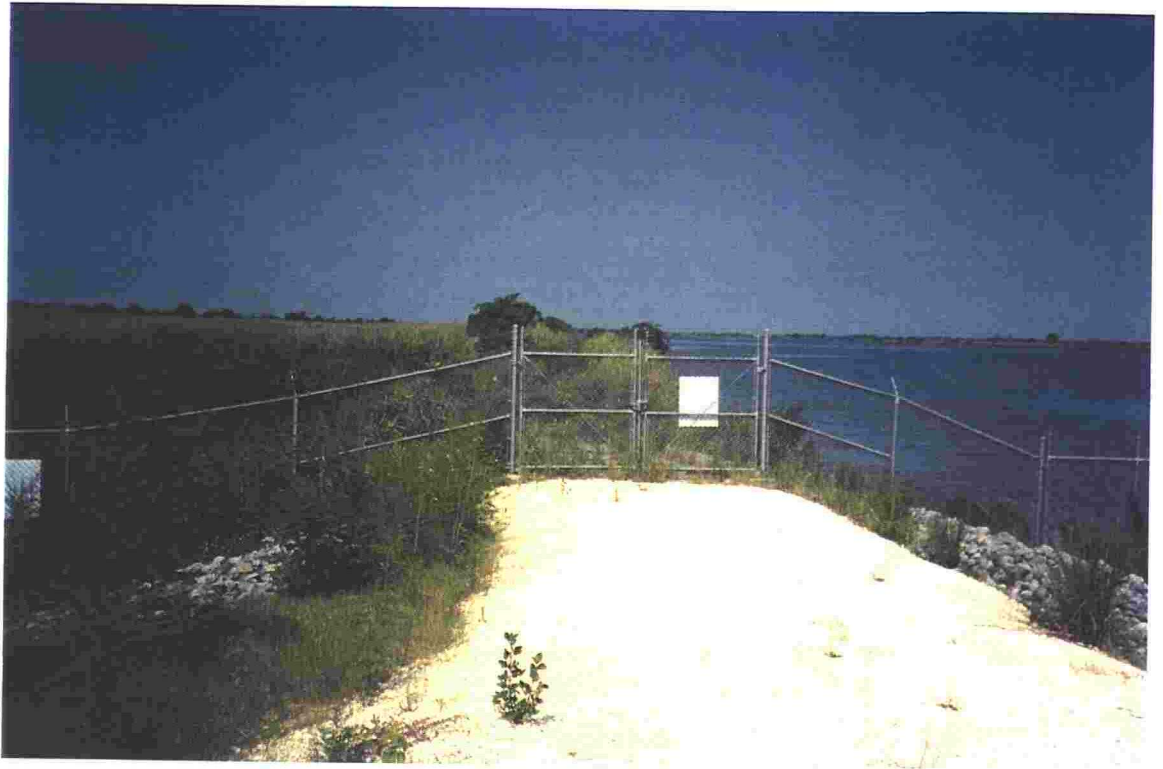
West site gate in good condition- all signs and locks in place

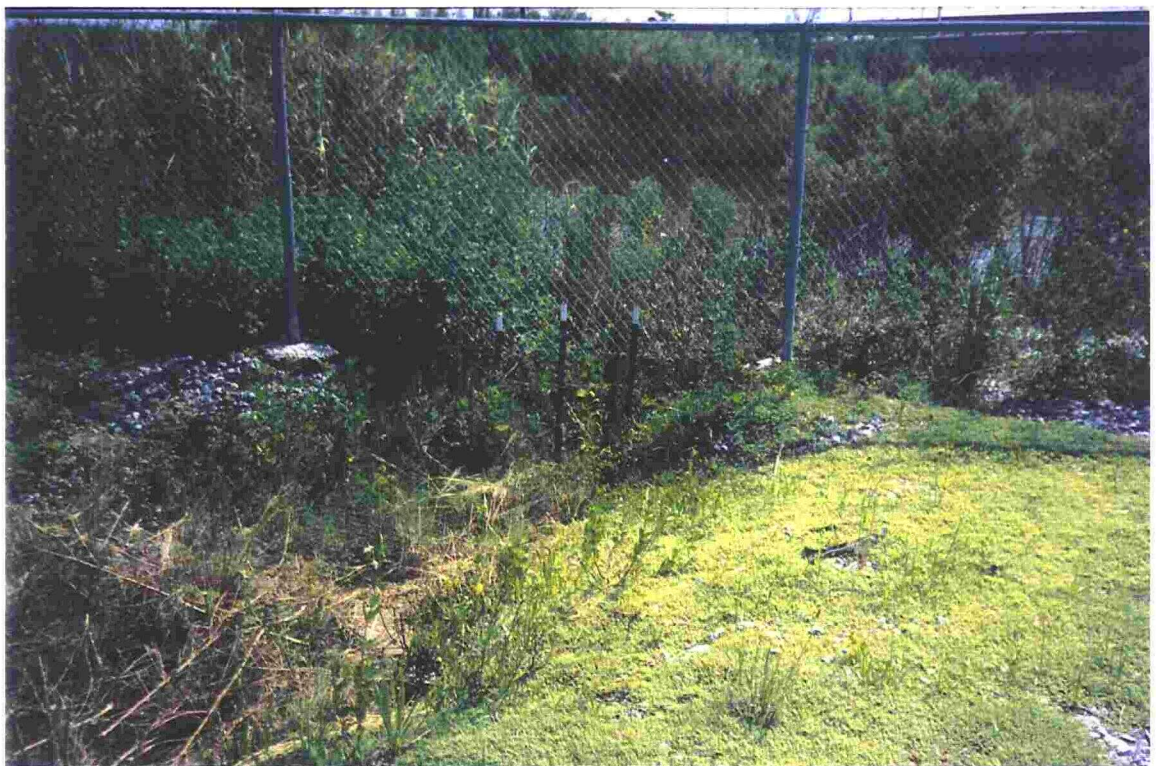
Drainage ditch from former laydown yard remains unobstructed

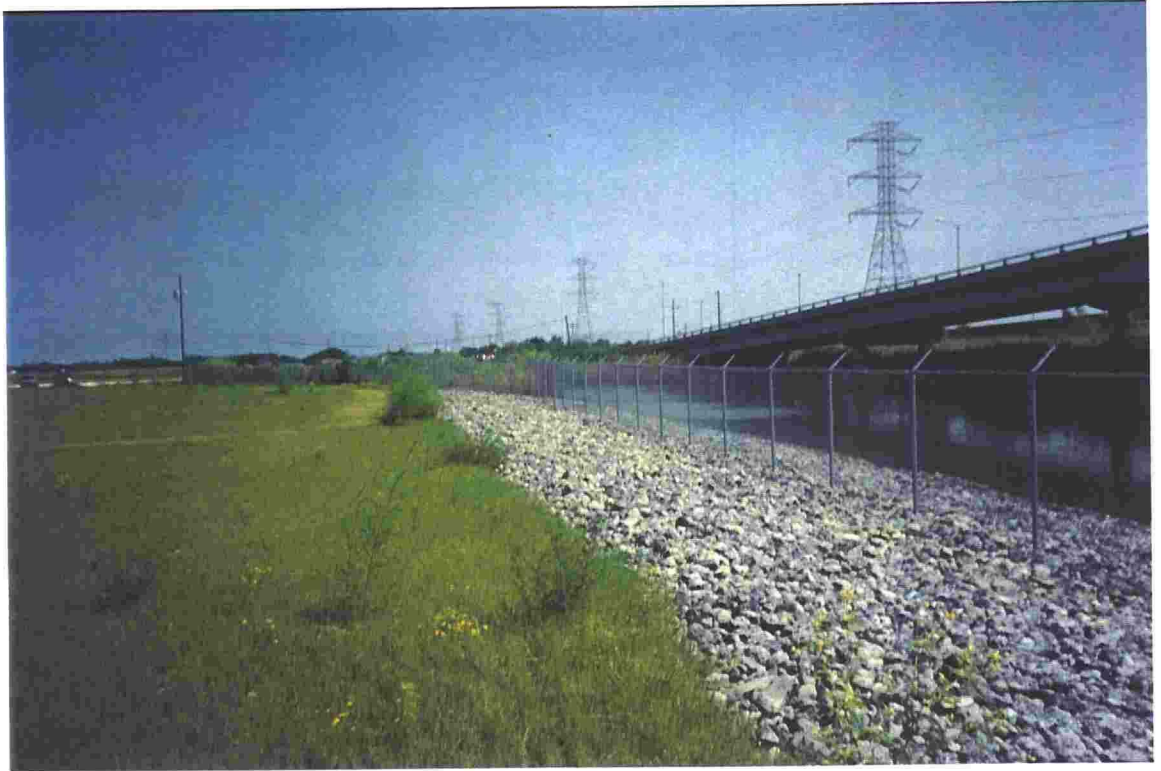
Perimeter security fence remains in good condition
